## Water disinfection using DabV

Tor-Henning Iversen dr.philos.,  
professor em. <https://bio-consult.net>

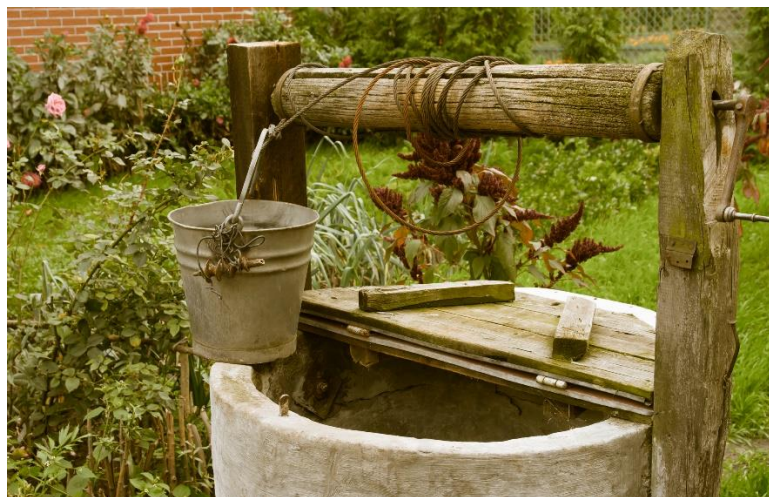
Figure 1. Experiment no 4 of a water well that had been left unused **for** a very long time.

Experiment no 4, which was a water well that has been left unused for a very long time (**Figure 1**). Initial analysis results of bacteria level were so high that quantification was not possible. The accredited laboratory therefore reported “overload” on all bacteria analysed. DabV was left in the well for one and a half months.

When the water in the well was analysed after one and a half months with DabV in the well, no bacteria could be detected (**Table 4**). The color number of the water in the well was very high (78), which shows the effectiveness in disinfecting water even at a high content of dissolved organic matters in the water. An extra DabV treatment was performed as it was not surprisingly expected that the water from the well did not have any bacteria as a result of DabV places in the well. This analysis also showed that no bacteria was detected.
